Fast Work Saves a Dike...and a River

The Sinkhole that Swallowed a Forklift

How Rembco filled a void and saved a department store

Sinkholes 101

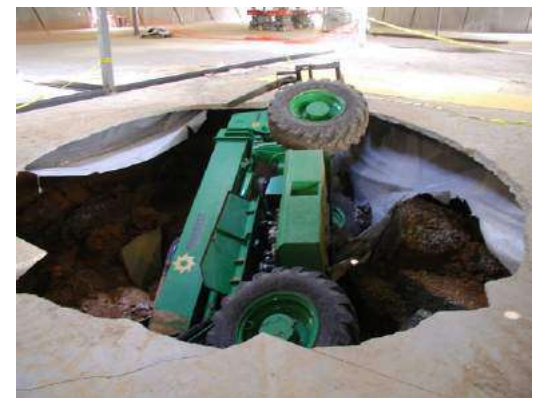
The anchor store for Bessemer, Alabama's newest shopping center was already under roof. As construction continued, the reach forklift operator stopped for a quick break. When he returned, a crowd was gathered around his forklift which now sat upside down at the bottom of a thirty foot opening in the concrete floor.

"This sinkhole was caused by solutioning of bedrock, eventually producing a hole," says Rembco owner, Clay Griffin. "Once a hole forms in the bedrock, ground water has a drain to move through. As it moves, it carries soil along with it. Over time, more and more soil is carried away and an underground void forms. The void grows until its domed ceiling eventually collapses and that is when a surface depression appears - sometimes dramatically."

"Additional subsurface investigation revealed karst activity under other portions of the building," says Griffin. "It turns out this department store had significant problems...well beyond the original dropout."

The plan for a typical deep sinkhole repair is to drill a pattern of holes down to the bedrock and 'cap' the solution feature by pumping in a thick, mortar-like

grout. After capping the defect in the bedrock, the Rembco team fills any voids in the subsurface and restores bearing capacity to the affected area with compaction grouting. (See animations of a typical sinkhole repair - [click here](#))

"But this was no ordinary sinkhole" says Griffin, "This was a monster sinkhole that eventually required 75 injections to depths of 110 feet." To create a solid foundation, 50 more injections were placed in other locations throughout the building. In all, 7,000 lineal feet of grout casing was advanced to bedrock, and a total of 2,700 cubic yards of grout was injected.

"Due to the widespread sinkhole activity under the building," says Griffin, "16 columns had settled beyond the allowable tolerances for the structure. We again used compaction grouting, this time to raise the sinking columns as much as 3 inches, bringing them within the required tolerance. To complete the job, we underpinned four columns around the original dropout with 12 drilled steel micropiles." Mission accomplished.

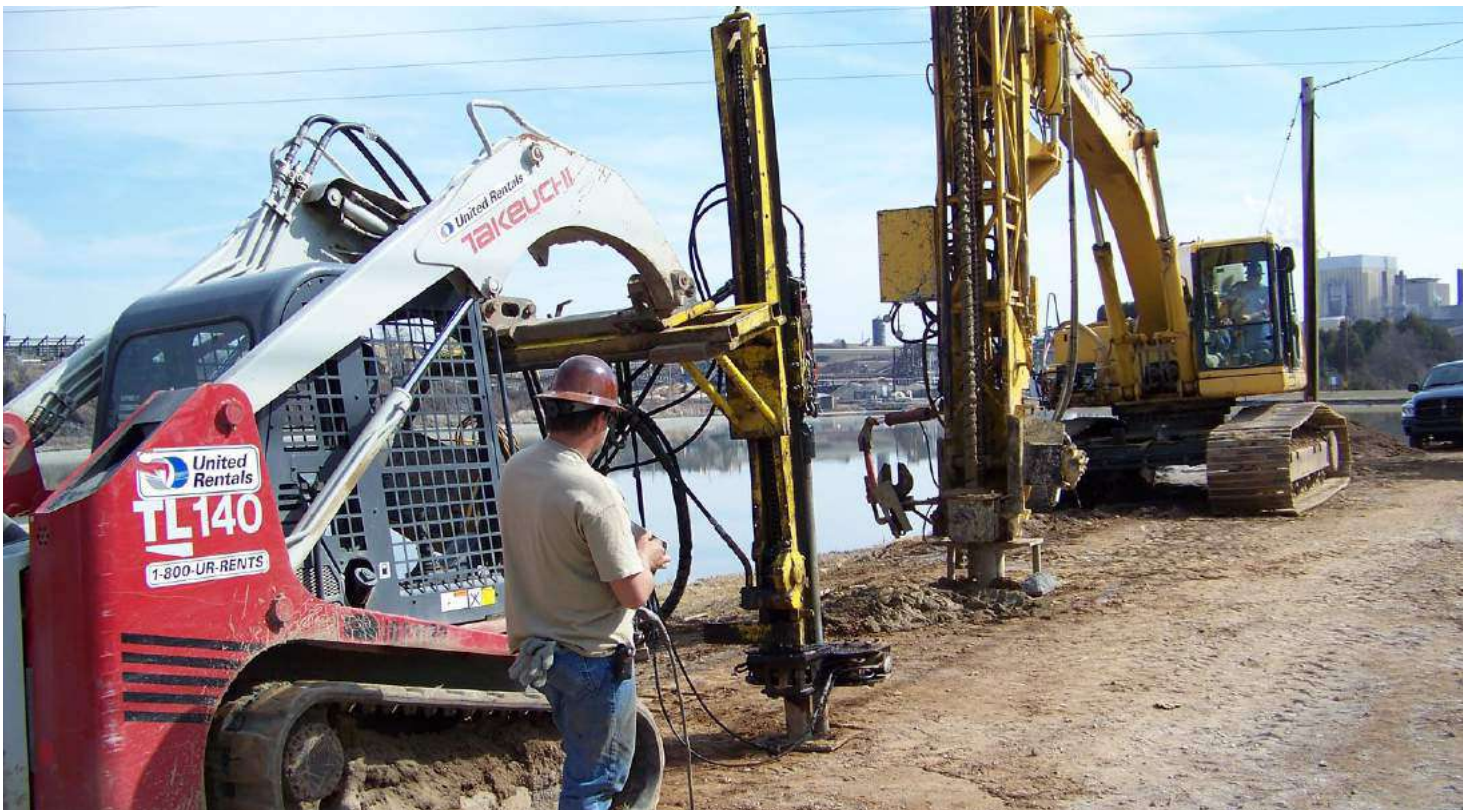
8:30 am, January 22: Rembco gets an urgent call from a paper products company. The dike on their wastewater pond is leaking badly and if it fails, millions of gallons of untreated effluent will empty into the adjacent river.

“Our initial assessment revealed that the water loss was about 34 gallons a minute at the high flow channel,” says Rembco Project Manager, Ken Bowman. “But water was also seeping out along a 200-foot stretch of the dike. “We immediately began polyurethane and compaction grouting, hoping to reduce the water flow into the river and, at the same time, improve the structural integrity of the dike. It was a race against time.”

As grouting projects go, this was a massive one. To stem the leaking, Rembco installed 3217 linear feet of casing and pumped in 2712 gallons

of polyurethane grout. To further stabilize the dike, the team installed 3515 linear feet of grout casing to accommodate 265 cubic yards of compaction grout. Using a combination of both treatments, Rembco reinforced a length of dike measuring 450 linear feet. Coordinating with the client’s geotechnical engineer, the team worked ten 24-hour days, followed by another 10 days on the site, continually assessing the conditions and modifying the approach as needed.

“When we demobilized to go home,” says Bowman, “the discharge was mitigated, the dike was stabilized, and a potential disaster was averted.”

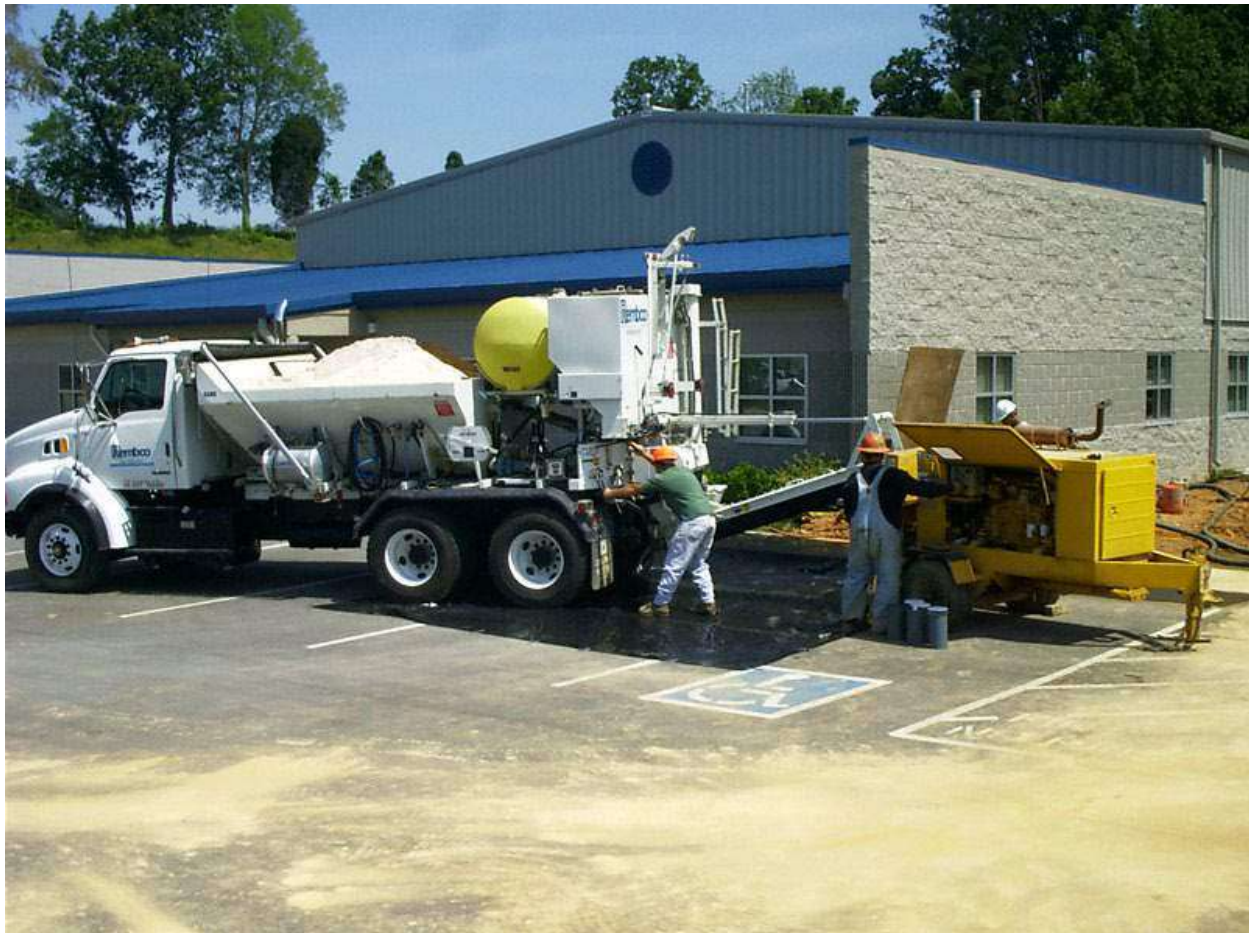
Officially known as the Zimmerman 400N1 Series Rear Discharge Concrete Mixer, Rembco's Zim® Mixer streamlines projects, increases efficiency and saves clients' money. In short, this mixer helps Rembco to be a lean, mean geotechnical services machine.

"Our Zim® Mixer is mounted on a flat bed truck that goes wherever we need it," says Rembco Director of Operations, Bill King. "It includes two aggregate bins, a cement bin, a tank for additives (like plasticizers,

thixotropes and retarders) and a 300 gallon water tank." "When it's operating," says King, "Water, cement, aggregates and additives are all metered, mixed and delivered by a system that is the most accurate in the industry. We can make virtually any quantity... from a wheelbarrow full to 30 cubic yards in just one hour. This mixer can handle any job."

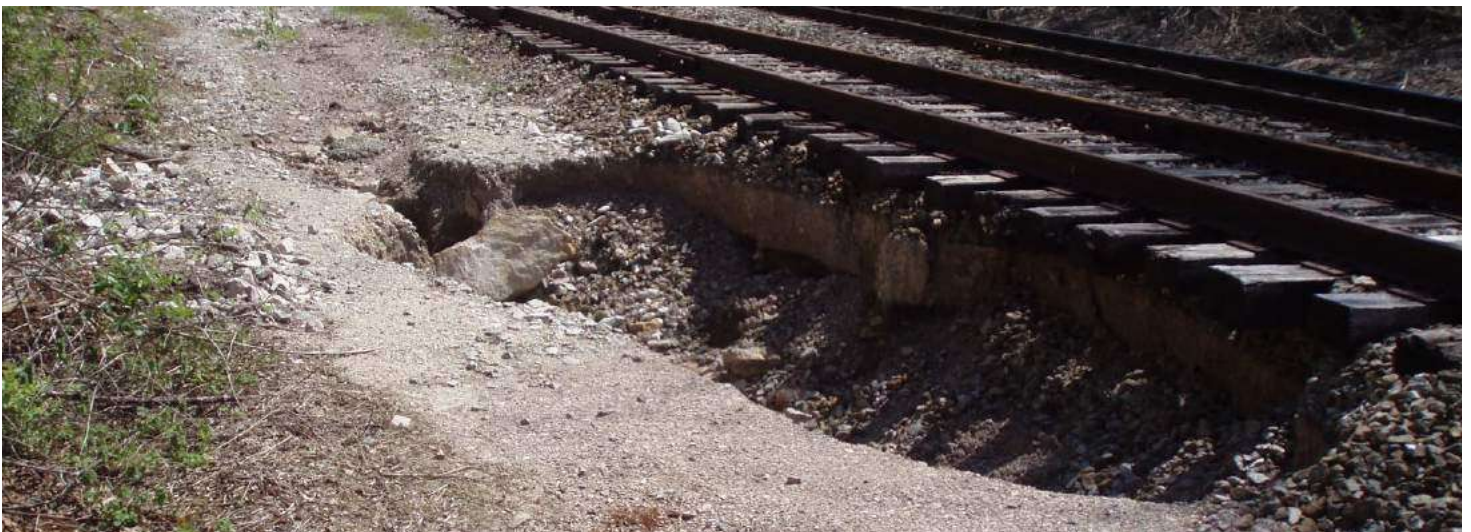
About 25% of land mass in the world is characterized as karst. Karst describes areas with sinkholes, caves, and underground streams which are formed by the slow dissolving of bedrock. When rainwater falls through the atmosphere and trickles through the soil, it becomes slightly acidic. In karst areas, this weak acid can dissolve holes in the bedrock or enlarge existing fractures, creating a "drain" for more groundwater. As water flows into the feature, it takes some of the surrounding soil with it, sometimes resulting in significant soil loss. At the ground surface, this may appear as a slowly sinking circular depression, or a very sudden dropout into collapsing soil caverns. And so... a sinkhole is born.

Remediation of sinkholes where bedrock is deep is accomplished by a process called "cap grouting". Steel pipes are drilled or driven to bedrock on a grid pattern that covers the affected area. A thick cement-based grout is pumped down the pipes and injected at the bedrock surface. The grout spreads out on the surface and creates a concrete "cap" that covers the bedrock defects. Cap grouting prevents further soil loss, but by itself does not address the disturbed and poorly compacted cone of soil from bedrock to the ground surface. So, as the grout pipes are slowly withdrawn, thick mortar-like grout is injected to displace and compact the surrounding soil. This "compaction grouting" restores the bearing capacity of the affected soil to prevent settlement of overlying structures.
